## **Restoration and repair of Félix Candela's most celebrated shell: 'Los Manantiales' Restaurant**

### **Abstract**

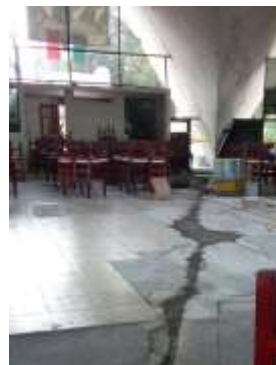
Also, it is important to mention that 'Los Manantiales' shell is practically at the foot of the hill where Nativitas borough is located, an area that is sinking due to the dehydration of the subsoil and which has caused a vast number of unpredictable cracks. The research and analysis carried out by 'Rescate Los Manantiales' also found that one of those cracks had already been present decades before the 2017 earthquake and exacerbated by it, thus causing damages to the shell (the crack crossed the interior of the shell axis "4" to axis "8" and branching to axis "1", forming a Y-shape).

Figure 6: Crack on the earth that damaged the shell.

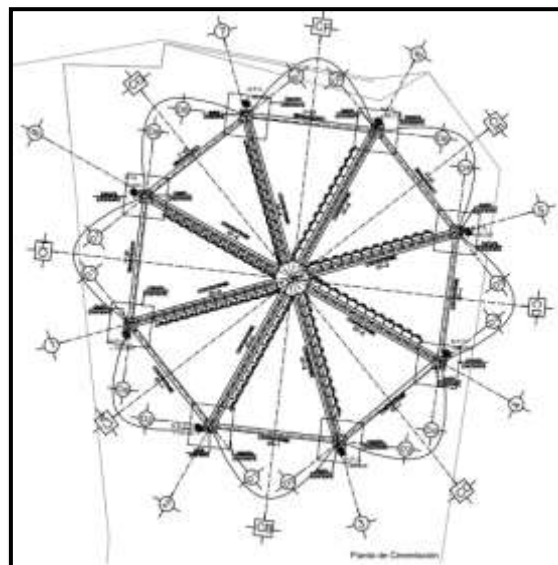
Figure 9: ‘Los Manantiales’ foundation plan showing existing repaired footings and new radial tie-beams.

current shell's foundation with piles and radial tie-beams as illustrated in "figure 9". It also dealt with the repair of all the interior floor concrete screed and slab as well as new electricity, gas, plumbing, and drainage works. The careful repair of finishes, landscape works, restoration of the mosaic-mural and the blacksmith work of the perimeter gates will also be accomplished after the structural repair has been done. It is important to note that throughout the first and second stages parts of the building have been kept in use. This uninterrupted, use of the building has been key to continue the sense of place and belonging of the community and to keep all stakeholders on board.

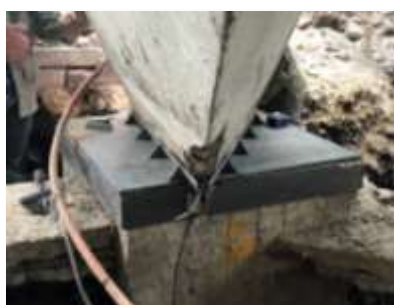
During the earthquake shear forces caused a significant displacement between the concrete cap of the footings and the groins generating a 5 mm crack between them. To repair this a connection steel plate with cavities on both sides was built to receive and secure the connection of the cap and the groin "figure 10".

Figure 10: Steel plate to strengthen the connection between the footing concrete cap and the shell's groin.

These plates were epoxied into the heart of the concrete footing cap and along with this, the necessary shoring was placed in all the footings with metal beams that passed tangent to the faces of the concrete cap to form a strap around and creating an 'H' shape to assist in distributing loads from the damaged foundations "figure 11". Two footings collapsed due to the weight of more than 300 tons of subsequent constructions that were built on them. These buildings were demolished. It is alarming to understand that the grand total of the deck has an approximate weight of 350 tons without considering any type of effort or extra live load and 300 tons were supported only on two supports. This was the fundamental reason for propping up the foundation with two metal arms that help the footings unload the weight of the restaurant onto two wooden beds that, in turn, transmit the weight and forces to the ground.

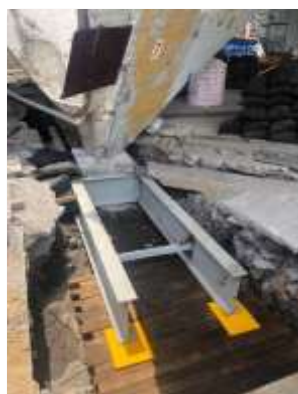
Figure 11: Existing footings connection with new radial tie-beams.

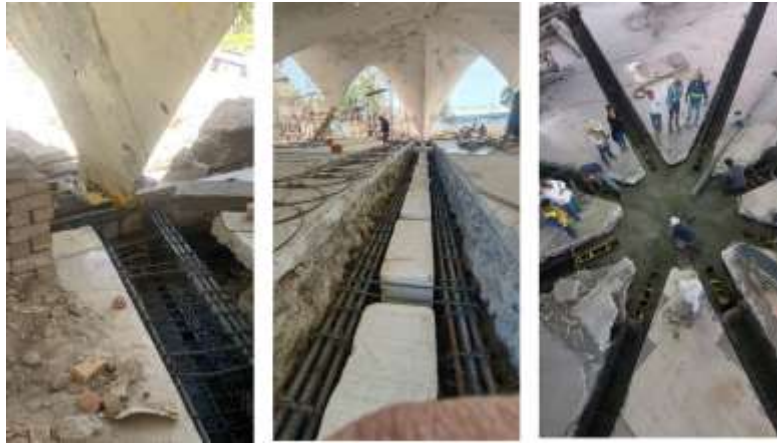
Figure 12a- 12c: New radial tie-beams connecting the shell’s footings.

Considering the complex characteristics of the soil, it was paramount to provide a robust anchoring of the shell to the ground and a series of 16 meters long friction piles were included as well as eight radial tie-beams running from footing to footing following the groins axis in plan “figures 12a-12c”. This strategy was developed to minimize the vertical movement of the shell produced by the trepidatory movement of an earthquake.

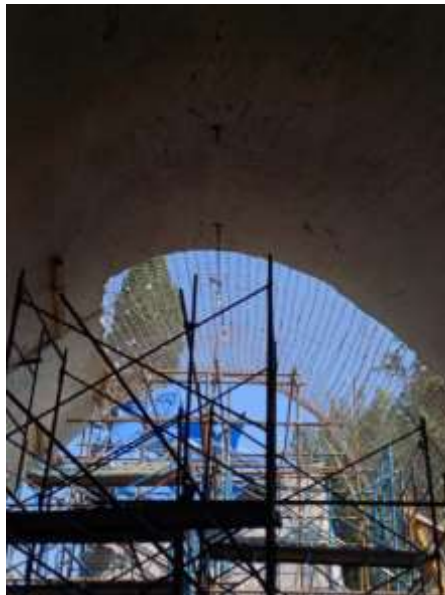
The section of the shell which had been severely damaged was partially demolished to repair and restore the original geometry of the shell “figure 13”. Other minor cracks presented on the shell were also sealed.

Figure 13: Partial demolition and repair of one of the ‘hypar’ shells.
