## **Consideration of resiliency in the repair and completion of a damaged cooling tower**

Phillip L Gould \*

### **Abstract**

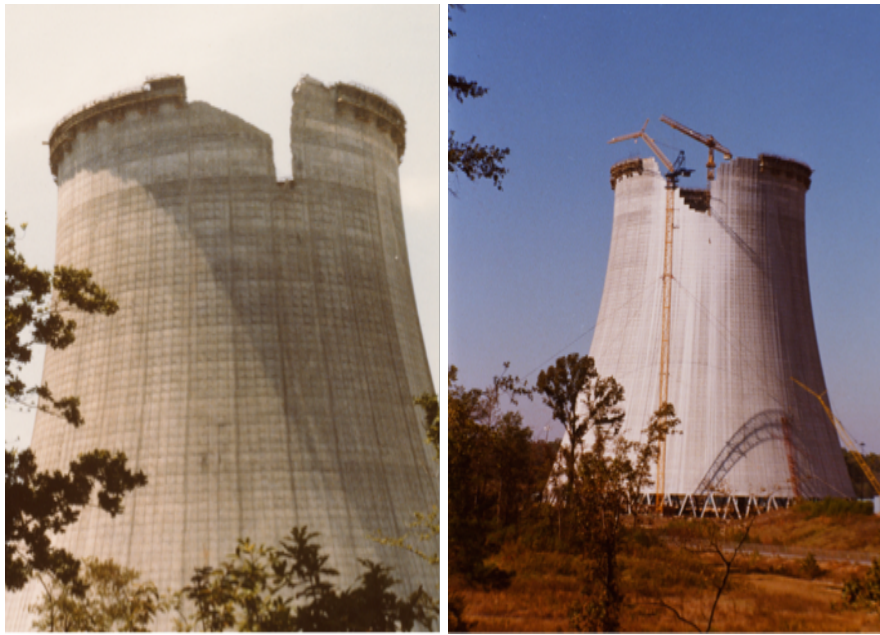
Figure 1: The damaged cooling tower and the restored crane during repair [1].

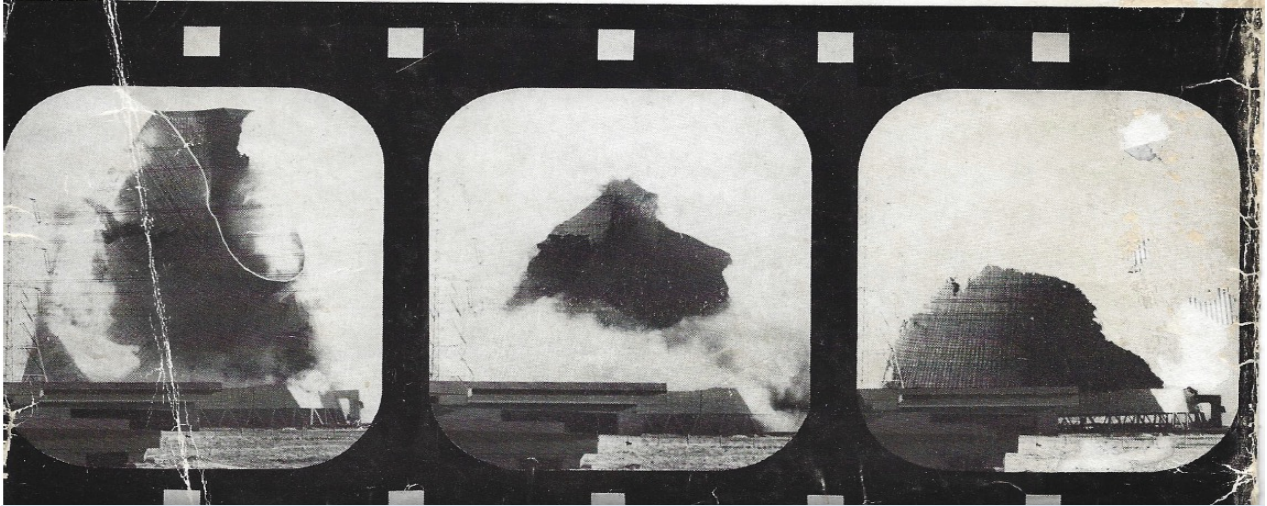
Figure 2: Collapse of Ferrybridge Tower [4]

- The Ferrybridge towers were subjected to a high but not extraordinary wind loading and those that failed were on the leeward side of the group.
- The failures were complete.
- The Ferrybridge towers were constructed as cone-toroids rather than the true hyperboloid of the Grand Gulf tower as shown in Fig.3. This resulted in significantly higher comparative stresses and apparently in somewhat different stress distributions.
- The Ferrybridge towers had only a single sheet of reinforcement in each direction, providing little bending resistance once the tension due to wind loading surpassed the dead load compression.

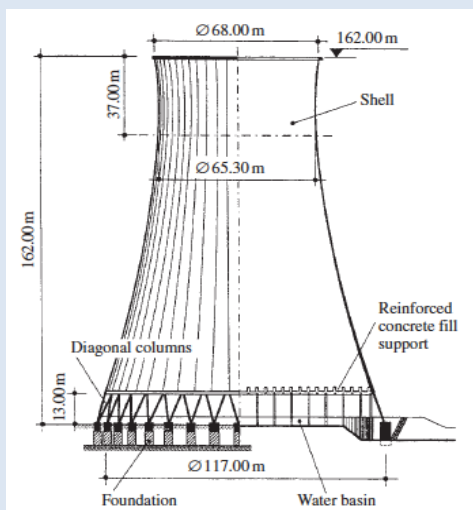
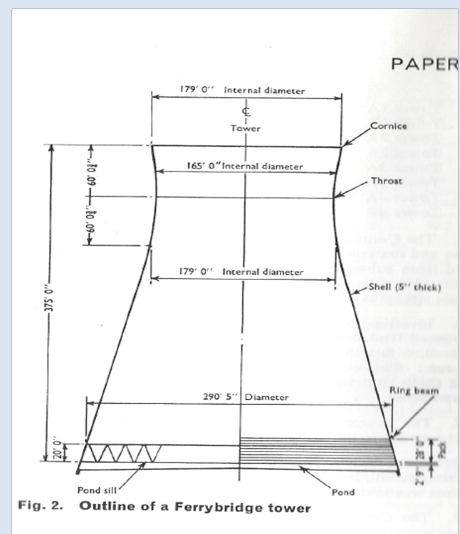
Figure 3: Comparison of Grand Gulf and Ferrybridge Towers [3,4]

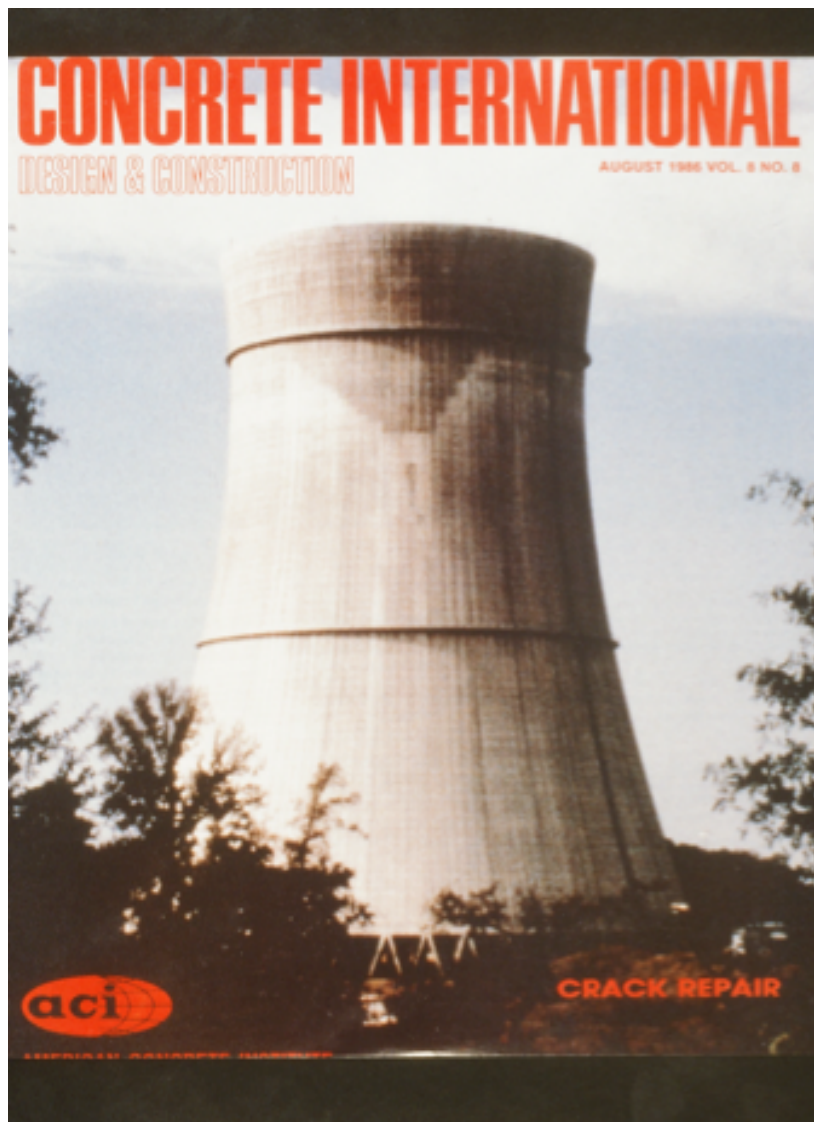
Figure 4: Completed Structure.[Concrete International,ACI]

- On the completed structure in Fig.4, the main damage surface is clearly shown by the shading change below the upper intermediate ring . While the damage penetrated into a rather large region of the shell as indicated by the crack pattern, it appears that alternate load paths were developed, a hallmark of resilience. The hyperbolic geometry provides two sets of straight line paths that may have aided this process.

In the case of the Grand Gulf tower, the decision was made to proceed with the proposed repair and completion of the tower following state-of-the-art design procedures and repair and reuse of the scaffolding. The completed shell is shown in Fig. 4. The purpose of the added intermediate rings is discussed later.

- In contrast to the strength analysis described above, the consideration of buckling under increasing wind load was not as straightforward. The widely used design criterion for thin shells in this era was a factor of safety  $\lambda = 5$  applied to the dead load plus wind load, i.e.  $\lambda(DL+WL)$ , instead of the logical  $(DL + \lambda W)$ . The  $\lambda(DL+WL)$  criterion was attributed to earlier roof shell design practice. While that requirement was met for the new shell geometry, a  $(DL + \lambda WL)$  calculation showed a slight decrease in the factor of safety. The decrease was compensated by the addition of the circumferential stiffeners based on published research [5]. Four stiffener locations were identified, the top cornice, the bottom thickened shell atop the columns, and two added precast post-tensioned rings as shown in Fig.6. The lower ring was installed in the vicinity of the maximum bulge while the upper ring provided a transition between the most damaged region and the to-be completed top portion.

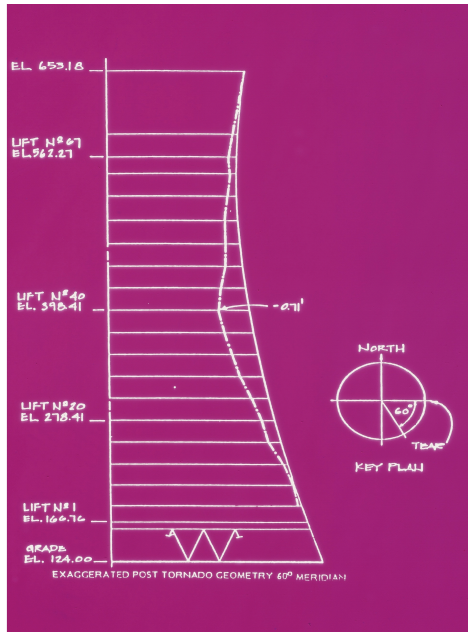
Figure 5: Bulge Profile [1]

- The original design specifications likely presumed an idealized theoretical geometry with some allowance for construction tolerances. However, the shell was repaired and completed based on the post-tornado geometry. This consisted of the measured geometry, including a significant bulge along one meridian shown Fig 5, up to the region of significant damage, the modified -as -necessary geometry in the damage area and the theoretical geometry to completion.

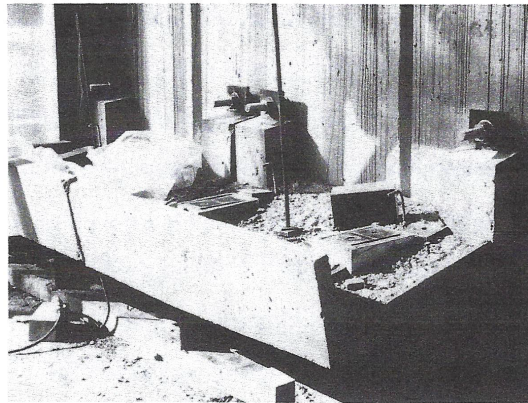
FIG. 16. Precast Stiffener Segment

Figure 6: Precast ring segment [1]
