## Prolonged life for the Ullevi stadium's cable suspended roof

Alexander SEHLSTRÖM\*, Lars SCHAGERSTRÖM, and Daniel EKSTRÖM

### Abstract

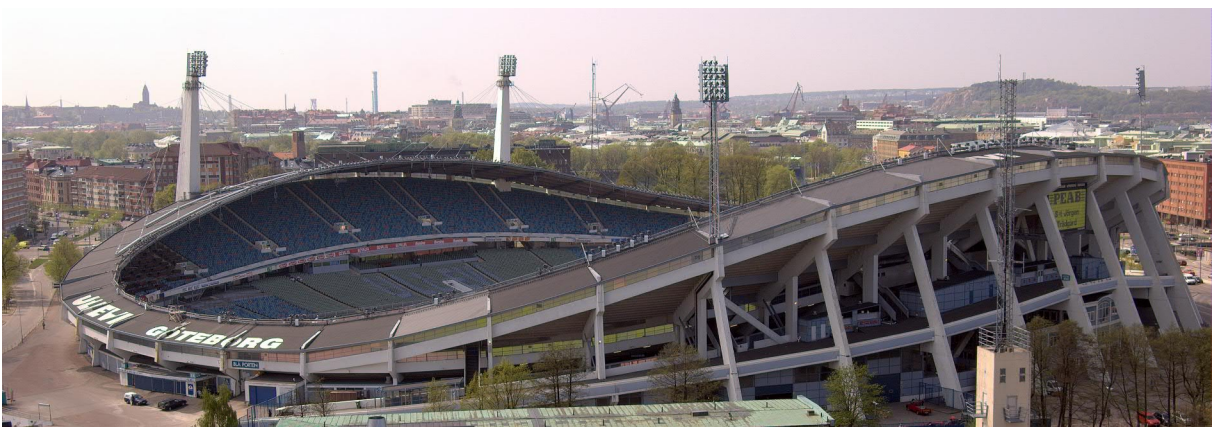
Figure 1: Ullevi as seen from the east with the pylons at the far end of the photo and the 1995 grandstand extension in the front. Photo [9].

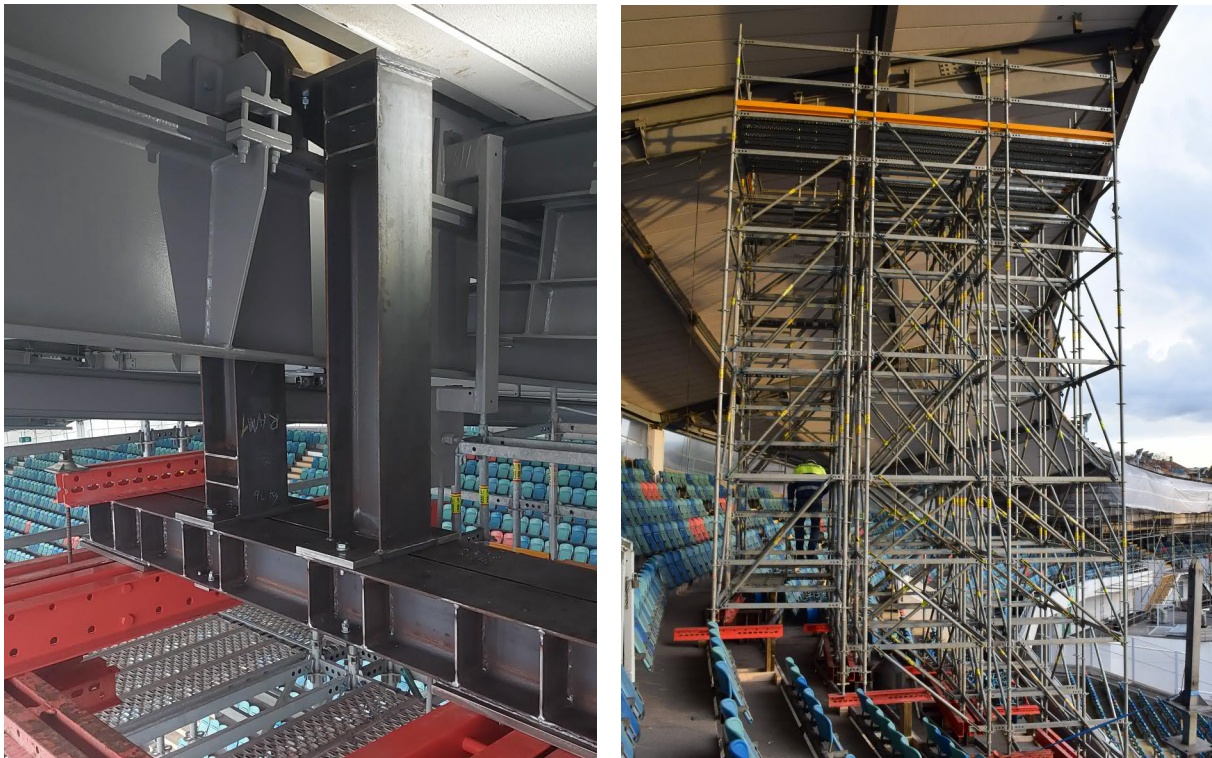
Instead, we opted for scaffolding towers. To handle the vertical load, the base dimensions of the tower needed to be  $4.8 \times 4.8$  m. As the grandstand consists of only 60 mm thick concrete elements with insufficient capacity to carry the tower, a load-transferring structure was placed underneath it, bringing the loads directly onto the 600–800 mm wide concrete frames under the primary roof beams. Additional diagonal studs and ties connecting the tower to the concrete frame it stands on and the two adjacent frames some 15 m away were used to handle non-vertical loads due to wind and imperfections and to reduce the tower's buckling length.

To change the load-bearing behaviour of the primary beam as little as possible, the primary beam needed to be supported by the tower below or near the intersection of the action lines of the primary beam and

Figure 5: The roof prop adaptor (unpainted) and transfer beams (red) temporarily supports the roof primary beam (gray), exerting a load of 720 kN on the scaffolding tower.

the cable. The vertical tie rods connected to the dampers mounted in 1987 were also attached at these intersection points and were temporarily detached. As the counter beams are clamped to the primary beams, their interface risk to form a hinge if put under compression. To avoid this, we developed an adaptor placed on a load-transferring system at the top of the scaffolding tower. The adaptor (fig. 5) consists of horizontal HEA beams from which two vertical HEA consoles upwards, one on either side of the primary beam. A plate extending from the top of the consoles provides via shelves welded to the web of the primary beams support for the roof.
