## Experimental study on wind uplift resistance of metal roofing system for large-span structures

This paper takes the metal roofing project of the Hefei Xinqiao International Airport Terminal 2 as a background, selecting two typical metal roofing specimens to conduct static wind uplift tests. The displacements and strains at key positions were measured, the mechanical properties and deformation characteristics of the roofing system were investigated, and the failure mechanisms were revealed, providing data support and reference for the design and construction of related engineering projects.

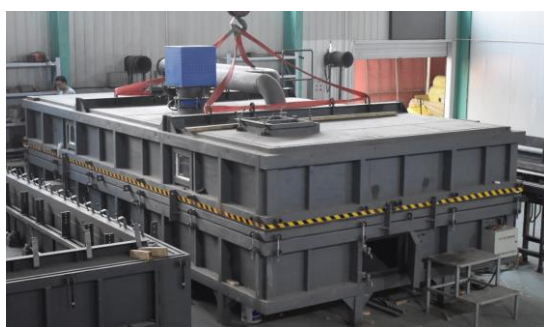
Figure 6: Test setup

The experiment was conducted in the enclosure system laboratory of Shanghai Xinxinjie Quality Inspection Co., Ltd., using a roofing comprehensive performance testing machine that is certified by FM Approvals. The dimensions of the test bench are 7700\*3900 mm, and the test setup is shown in Figure 6. When installing specimen W1, first secure the purlins to the test bench and fix the supports on the purlins. Then, lay the roof panels from one side to the other in sequence, connecting adjacent roofing panels via a seaming machine. When installing specimen W2, based on the setup of W1, continue by securing the anti-wind clips to the ribs of the roofing panels, and connect the partition keels to the anti-wind clips, finally securing the decorative panels to the partition keels. It is important to note that both specimens W1 and W2 require a layer of polyethylene film to be laid under the roof and decorative panels to form a sealed space, in order to apply negative wind pressure on the roof and decorative panels.

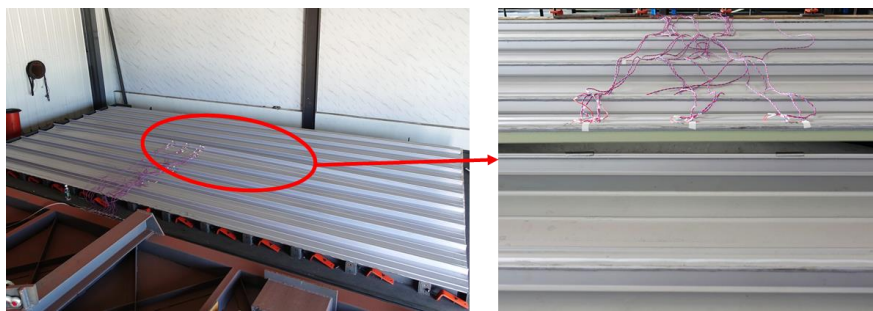
Figure 10: Roof panel seam disengagement

In the second loading stage, a loud noise occurred when the load was increased to 14.0 kPa, indicating severe disengagement at the seam engagement areas of the standing seam steel panel at the mid-span, as shown in Figure 10. No significant straightening of the upper bent arcs of most supports was observed, and the ultimate wind pressure was determined to be 13.3 kPa.

(2) Under wind uplift loads, the main failure modes of the standing seam metal roofing system are disengagement at the seam interlock and straightening of the supports. This indicates that the seam

interlock connections are the weak points of the standing seam metal roofing system. Therefore, in actual engineering projects, these weak points should be reinforced to enhance the overall wind uplift resistance of the standing seam metal roofing system.

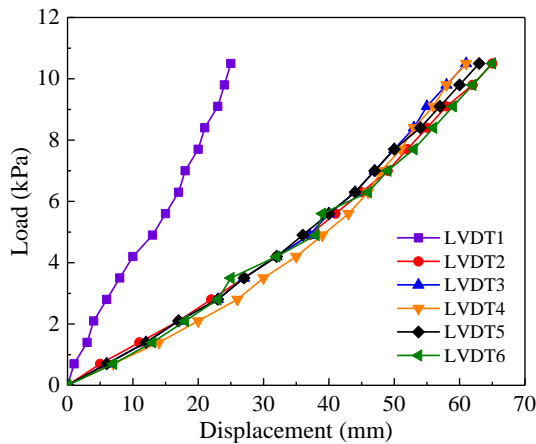
Figure 12: Load-displacement curves

The load-displacement curves and load-strain curves for specimen W1 are shown in Figures 12 and 13, respectively. From Figure 12, it is evident that during loading, the deformation of the roof panel generally shows an approximately linear increase with load, indicating that it is in the elastic deformation stage. The deformation at the mid-span of the roof panel (L2~L6) is significantly greater than the deformation at the rib interlock (L1).
