Walking on eggshells: innovative methods to justify reuse of a historic thin shell roof at Smithfield Poultry Market

Guusje UBACHS^{a,*}, Christopher NOBLE^a, Balduino DEL PRINCIPE^a, Richard LAWSON^a

Abstract

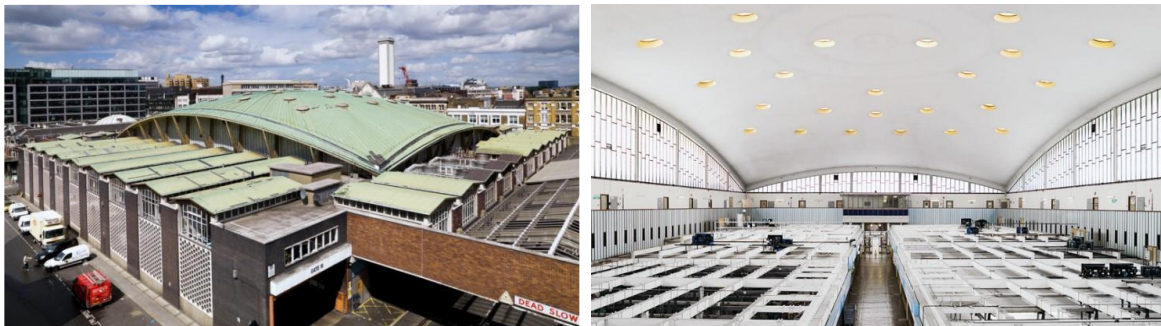
Figure 1 – Smithfield poultry market exterior (left) and interior (right) © Historic England Archive

London's Smithfield Poultry Market roof presents an example of how concrete shells can be reimaged through a change of use of the large space they enable, and the challenges of doing so. It is a doubly-curved elliptical paraboloid concrete shell spanning approximately 70m by 40m, with a design thickness of 76mm – only 1/13th of the thickness of an eggshell when compared to its relative span. Constructed in the 1960s, this shell was at the forefront of engineering as one of the largest of its kind.

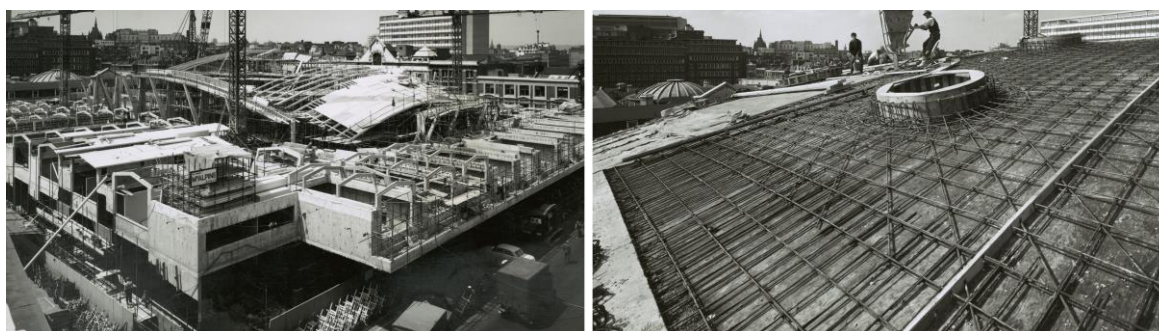
Figure 4 – Construction of the market roof in the 1960s © John Maltby

The building was constructed in the early sixties by Sir Robert McAlpine. The columns and edge beams were constructed first, and a small amount of post-tensioning was applied to the edge beams. The formwork for the roof shell consisted of singly-curved plywood panels, which were faceted in one direction to achieve the doubly-curved shape. The roof was cast in sequence, working from the corners towards the middle of the roof. A series of openings and upstands for rooflights were cast into the structure in this process as well.

Once the shell was cast, the edge beams were prestressed in a symmetrical sequence. A sliding detail at the corner columns during the construction stage allowed the roof to lift off the formwork during the post-tensioning. Once this was complete, the finishes build-up was laid on the roof, completed with the now iconic copper finish on the top. The market was opened in May 1963, and was reported to be the largest concrete shell of its type at the time by [3].

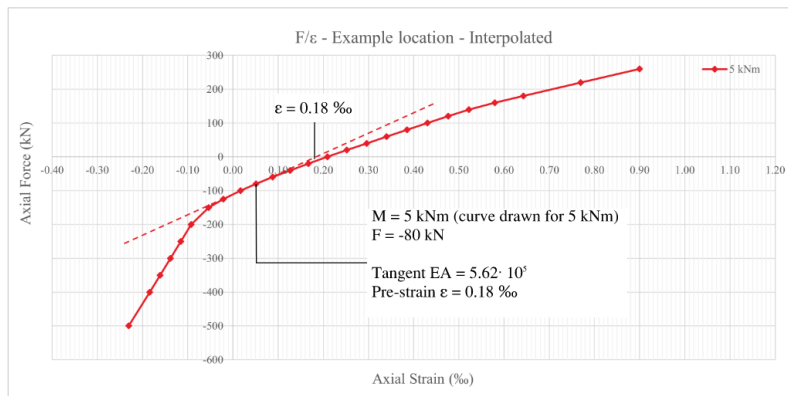
Figure 9 – Example calculation of in-plane stiffness from F- ϵ graph with a 5kNm moment in the element

To determine the cracked in-plane stiffness in the elements, the tangent in-plane stiffness with strain offsets were used instead of the more commonly used secant stiffness. When using the force-strain (F- ϵ) curves to determine in-plane stiffnesses, a secant stiffness may result in negative values which can result in errors in the FEA program. To assess the correct stiffness, the F- ϵ curve is drawn for the specific bending moment that the element pair experiences. The tangent slope to this curve at the point of the axial force in the element is then used in combination with a strain offset. This strain offset can be found at the intersection of the tangent with the x-axis (strain), see Figure 9. This initial strain is then applied to the FEA in-plane shell element as a pre-strain in combination with the slope of the curve to represent the correct in-plane stiffness, i.e. EA_x with ϵ_x and EA_y with ϵ_y represent the in-plane stiffness in the element local x and y directions, respectively.

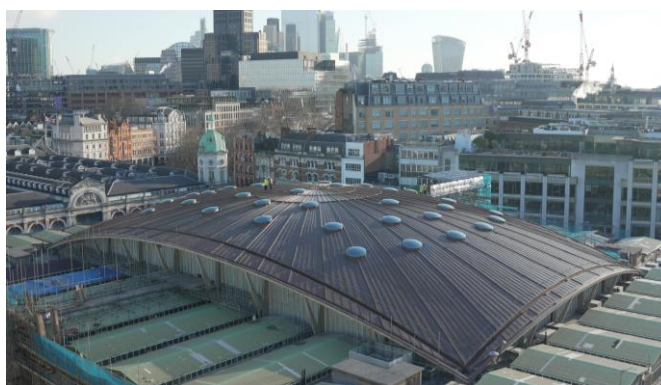
Figure 11 - New copper finishes on the roof (taken March 2024) © FMJ Limited

Thanks to the outstanding work undertaken, the old finishes were removed, and the placing of the new finishes was completed with the final piece of copper laid in December 2023 by Chris Johnson, who worked as an apprentice with the original roofing team in the 1960s. Monitoring was carried out throughout the construction of the new finishes and showed the roof behaviour was as expected. The roof is now ready for the works inside the building to commence to turn the market hall into a museum.
