## **Restoration and repair of Félix Candela's most celebrated shell: 'Los Manantiales' Restaurant**

### **Abstract**

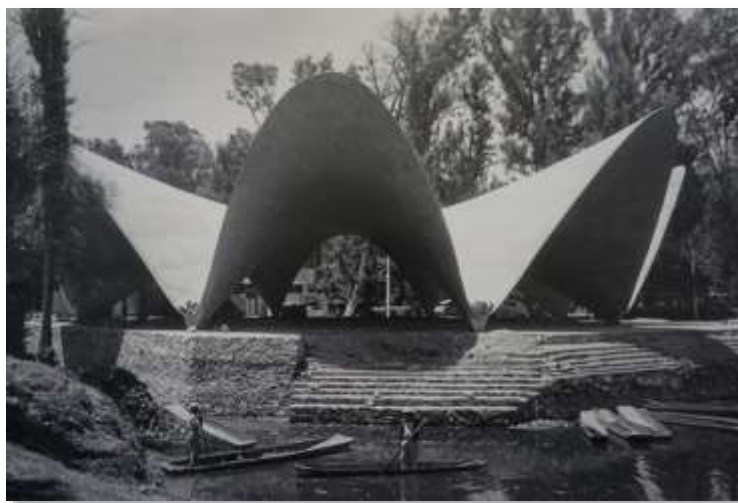
The computer simulations carried out to predict deformations showed that under seismic movements of  $M_w$  9 deformations at the highest crest of each ‘hypar’ of the shell could reach a horizontal displacement of up to 20 cm. Under the simulation conditions, once the earthquake had concluded the elastic behaviour of the shell allows it to return to its original shape. However, the poor quality of the soil and the 7.1 moment magnitude earthquake on September 19, 2017, exerted high stresses one of the of the shell causing plastic deformation and resulting in the structural failure of the footing. Moreover, the footing failure influenced the perimeter tie-beam which in turn pushed down the eastern footings displacing the soil outwards to the canal. The soil displacement was exacerbated by the gradual lake draught which had reached a 5-meter drop. The original masonry steps that worked as a retaining wall on the edge of the canal “figure 8” was removed in the 1990s and replaced by an unfinished concrete wall. The presence of a retaining wall on the edge of the canal would have been of vital relevance to avoid this soil displacing and the sinking of the footing in axis 6. The failure of the footings and the tie-beam deformed the ‘hypar’ edges in axis 7 and 8 losing its original geometry.

Figure 8: ‘Los Manantiales’ original masonry steps on the canal side.
